# **D.U.L LABORATORIES LTD**

**1.5M<sup>3</sup> Furnace Test on two Hoody fireproof acoustic covers in accordance with BS EN 1363-1:2020 and BS EN 1634-2:2020 Fire Resistance Tests, General Requirements.**

**Test Report No:** DUL-00091

**Test Date:** 05<sup>th</sup> of December 2023

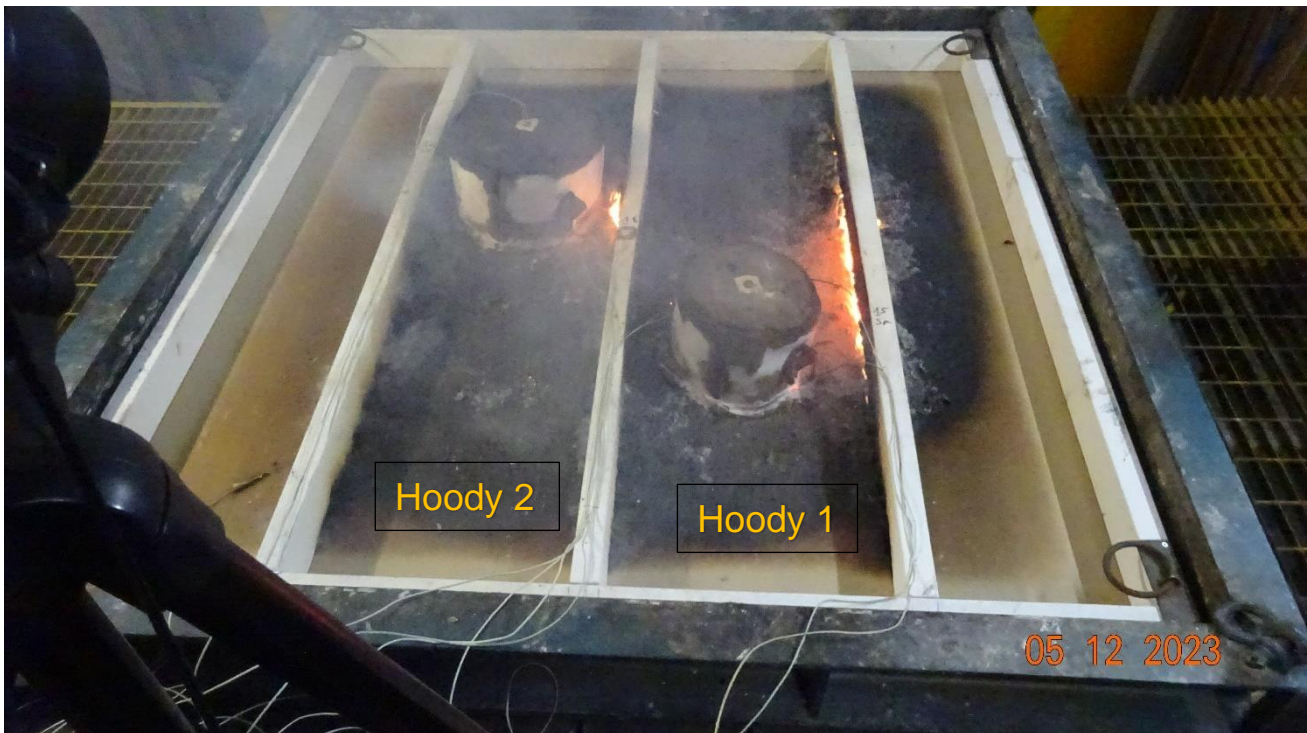
Image of unexposed face of specimen at 90 minutes

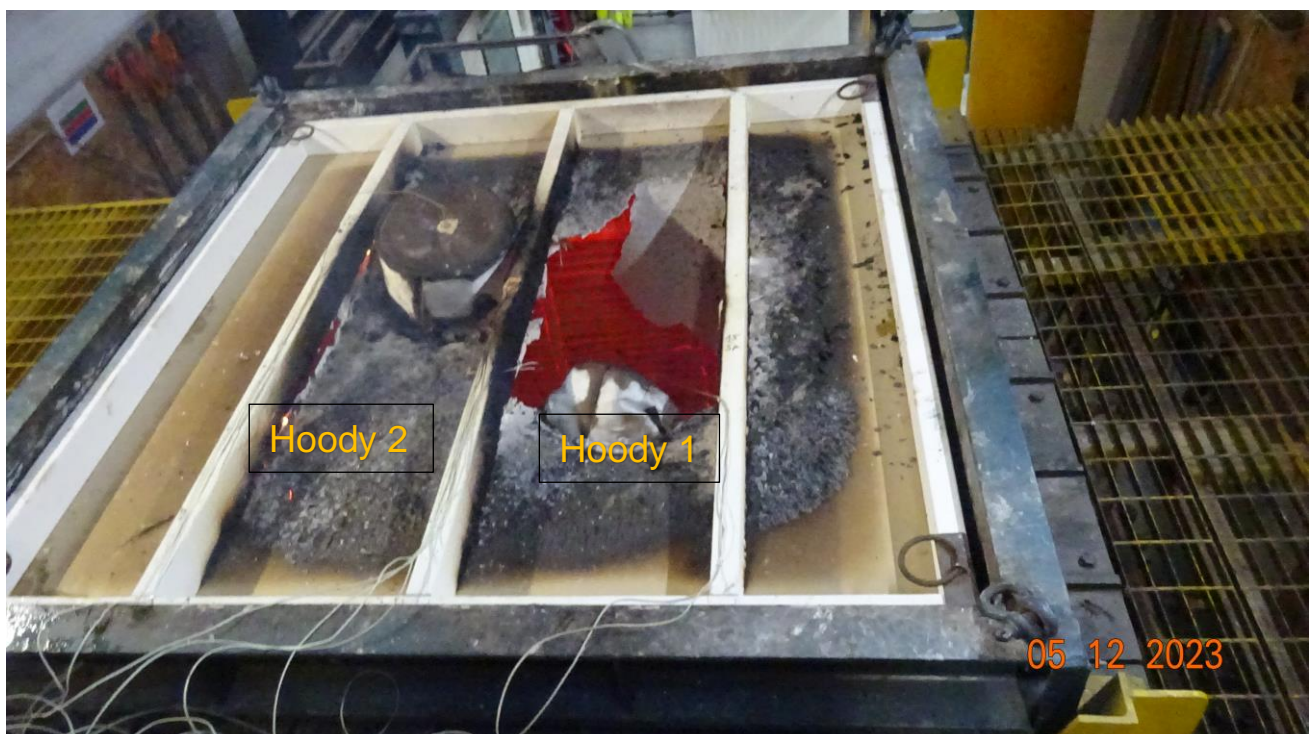
The test was run for **107 minutes** and was stopped at the request of the sponsor, when the plasterboard cracked, and flames started penetrating through.

Image of unexposed face of specimen at 107 minutes (end of test)
